Report of the  
Hawke's Bay  
**Facing the Risks**

Engineering Lifelines Project

# Facing the Risks

© 2001 Hawke's Bay Engineering Lifelines Project  
HBRC Plan No. 3065

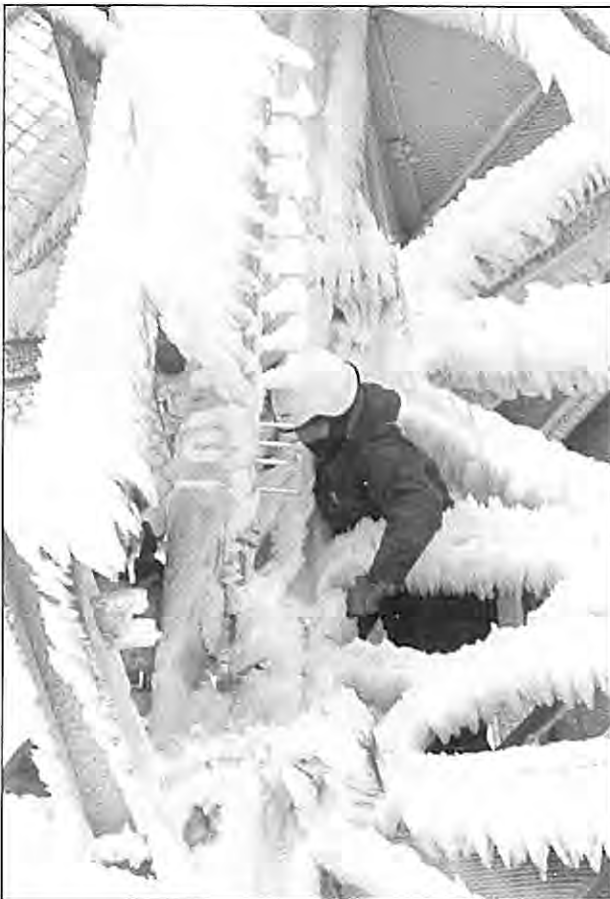
*A rigger is clearing snow from a yagi antenna. This photo illustrates the "flag ice" phenomenon and the impact it can have on both the tower and the antenna's attached to towers.  
(Photo courtesy Ian Greaves Telecom)*

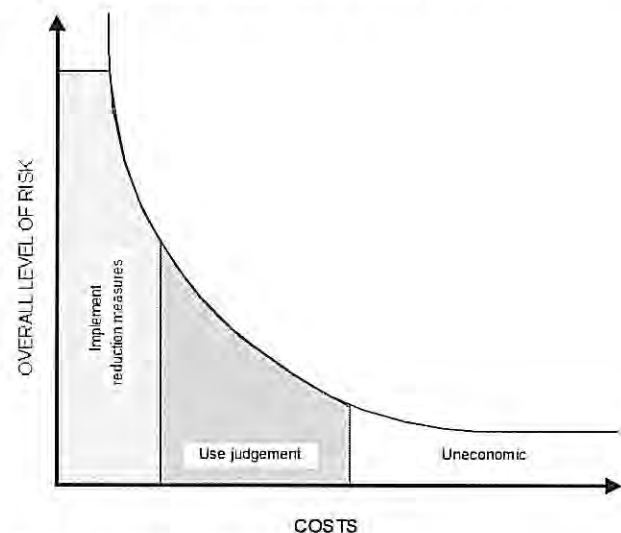
Figure 4.3 Cost of Risk Reduction Measures

Where large reductions in risk can be achieved with relatively low expenditure, these options should be implemented. Further improvements may be uneconomic and it will be a matter of judgement as to whether they can be justified. This is illustrated in Figure 4.3 below, from NZS4360: 1999.

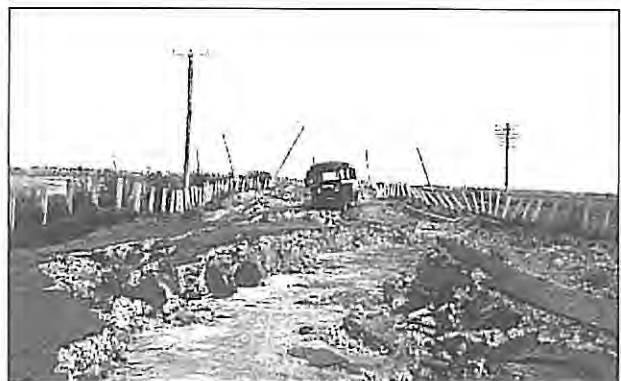
*Bus stranded on crumbled road near Poukawa 1931. Fence line and power poles have buckled along the road due to intense shaking. (Photo Institute of Geological and Nuclear Sciences)*

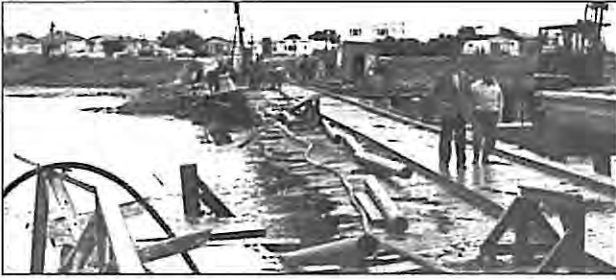
*Damage in the Ahuriri Channel caused by the 24 May 1960 tsunami, which struck Napier. The old footbridge linking Napier and Westshore was carried away, damaging gas and water mains and cutting a telephone cable. (Photo courtesy Russell Spiller.)*

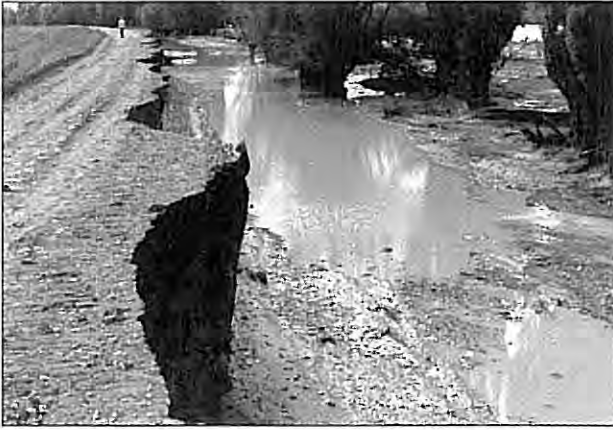
*Ngaruroro River Stopbank with scour damage after Cyclone Bola 1988.  
(Photo courtesy HBRC)*

Major flood protection systems have been completed on the Heretaunga and Ruataniwha Plains. These have significantly reduced the risk of small to medium sized floods adversely affecting adjacent land. However a large flood could overwhelm the works and have a devastating effect. Such a flood, which exceeds the design capacity of the flood protection system, or results in the premature failure of river control works, is called a "super design flood".

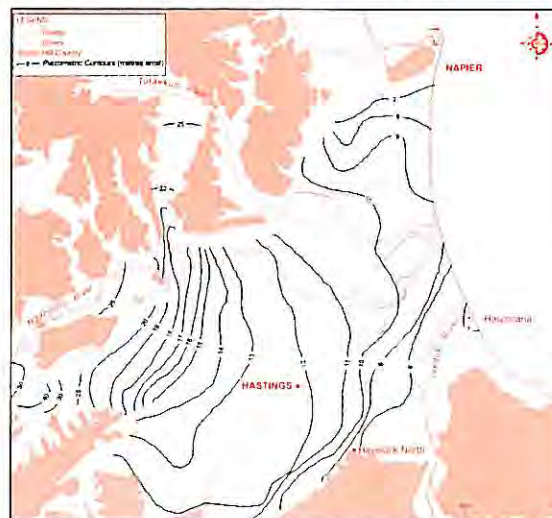
Figure 4: The Heretaunga Plains summer 1995 piezometric map.

Water flows in the system are generally from west to east. South-eastward flows predominate to the east of Flaxmere and north-eastward flows predominate in the Taradale – Napier area. Figures 3 and 4 (5.5 and 5.6 of Dravid and Brown) illustrate some winter and summer water pressures measured on the Heretaunga Plain. Water flows from high pressure to low pressure areas. The figures show some of the evidence of water flows through the system from the bed of the Ngaruroro River upstream of Fernhill.

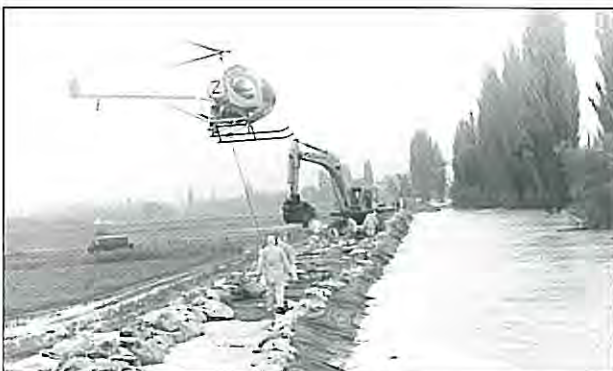
Ngaruroro River stopbank Cyclone Bola 1988

Much of the intensely cultivated and populated areas of the Heretaunga and Ruataniwha Plains are protected by stopbanks. In general, these stopbanks are designed to cope with a 100-year return period flood, with some freeboard.

The freeboard may provide enough capacity to sustain a less frequent but more extreme event. However floods with a return period of 475 years are likely to exceed the stopbank capacity and lead to overtopping and breaching. Just where this breaching would occur is not known.

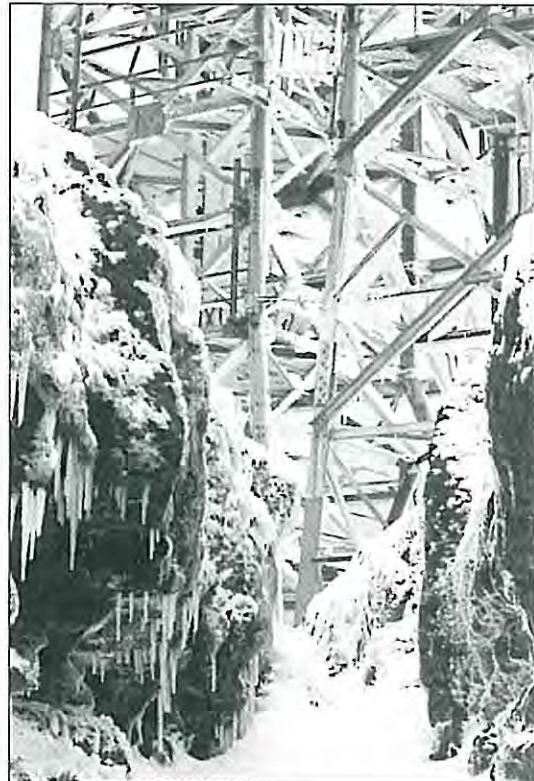
Snow and ice conditions at TeWaka Repeater Station taken from a perspective between 2 rock outcrops. At the time of this photo there were 2 towers on the site, the smaller one in the foreground has since been dismantled and removed. (Photo courtesy Ian Greaves Telecom)

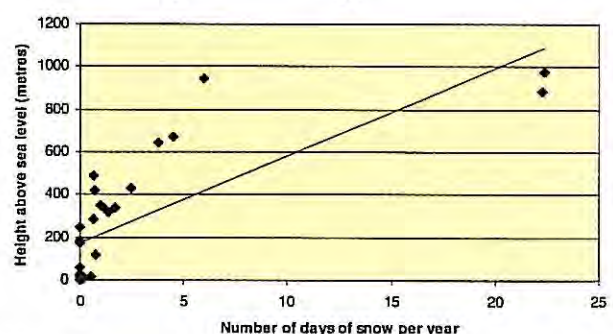
Figure 3.1 Frequency of snowfall in the Hawke's Bay region.

The results are presented in Figure 3.1 below

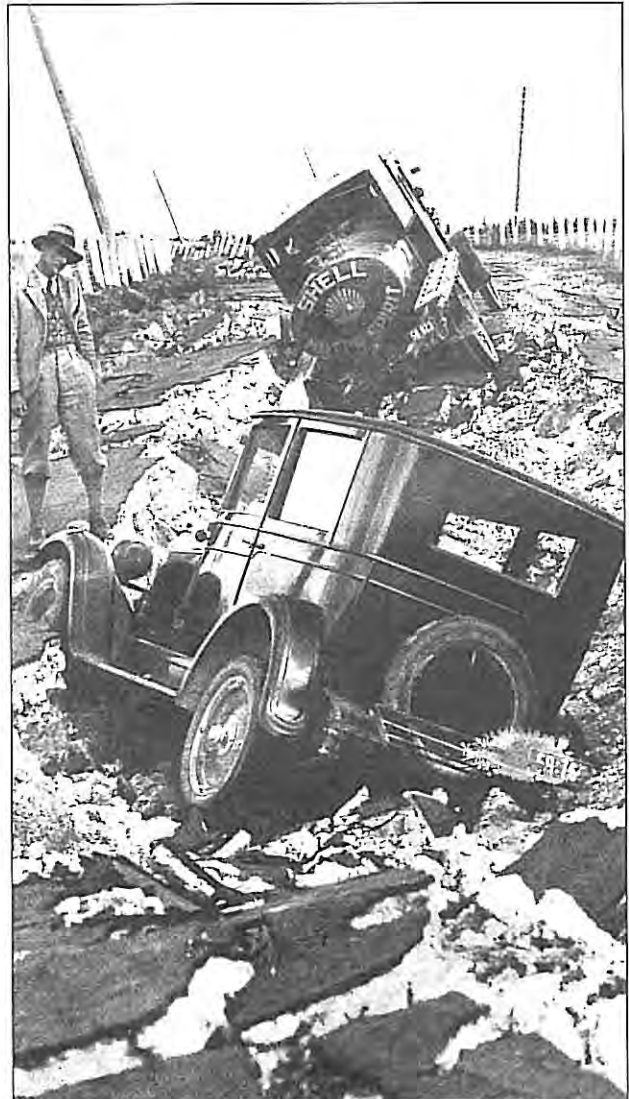
*Westshore Embankment Road following 1931 Hawke's Bay Earthquake.*

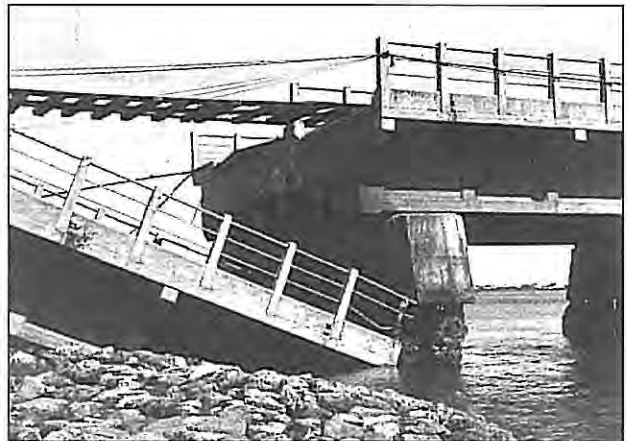
1931 Hawke's Bay Earthquake. Lateral spread of the embankment has allowed the landspan to drop off the first pier support collapsing it to the ground. The rail track has remained suspended free of the fallen bridge. (Photo Institute of Geological and Nuclear Sciences)

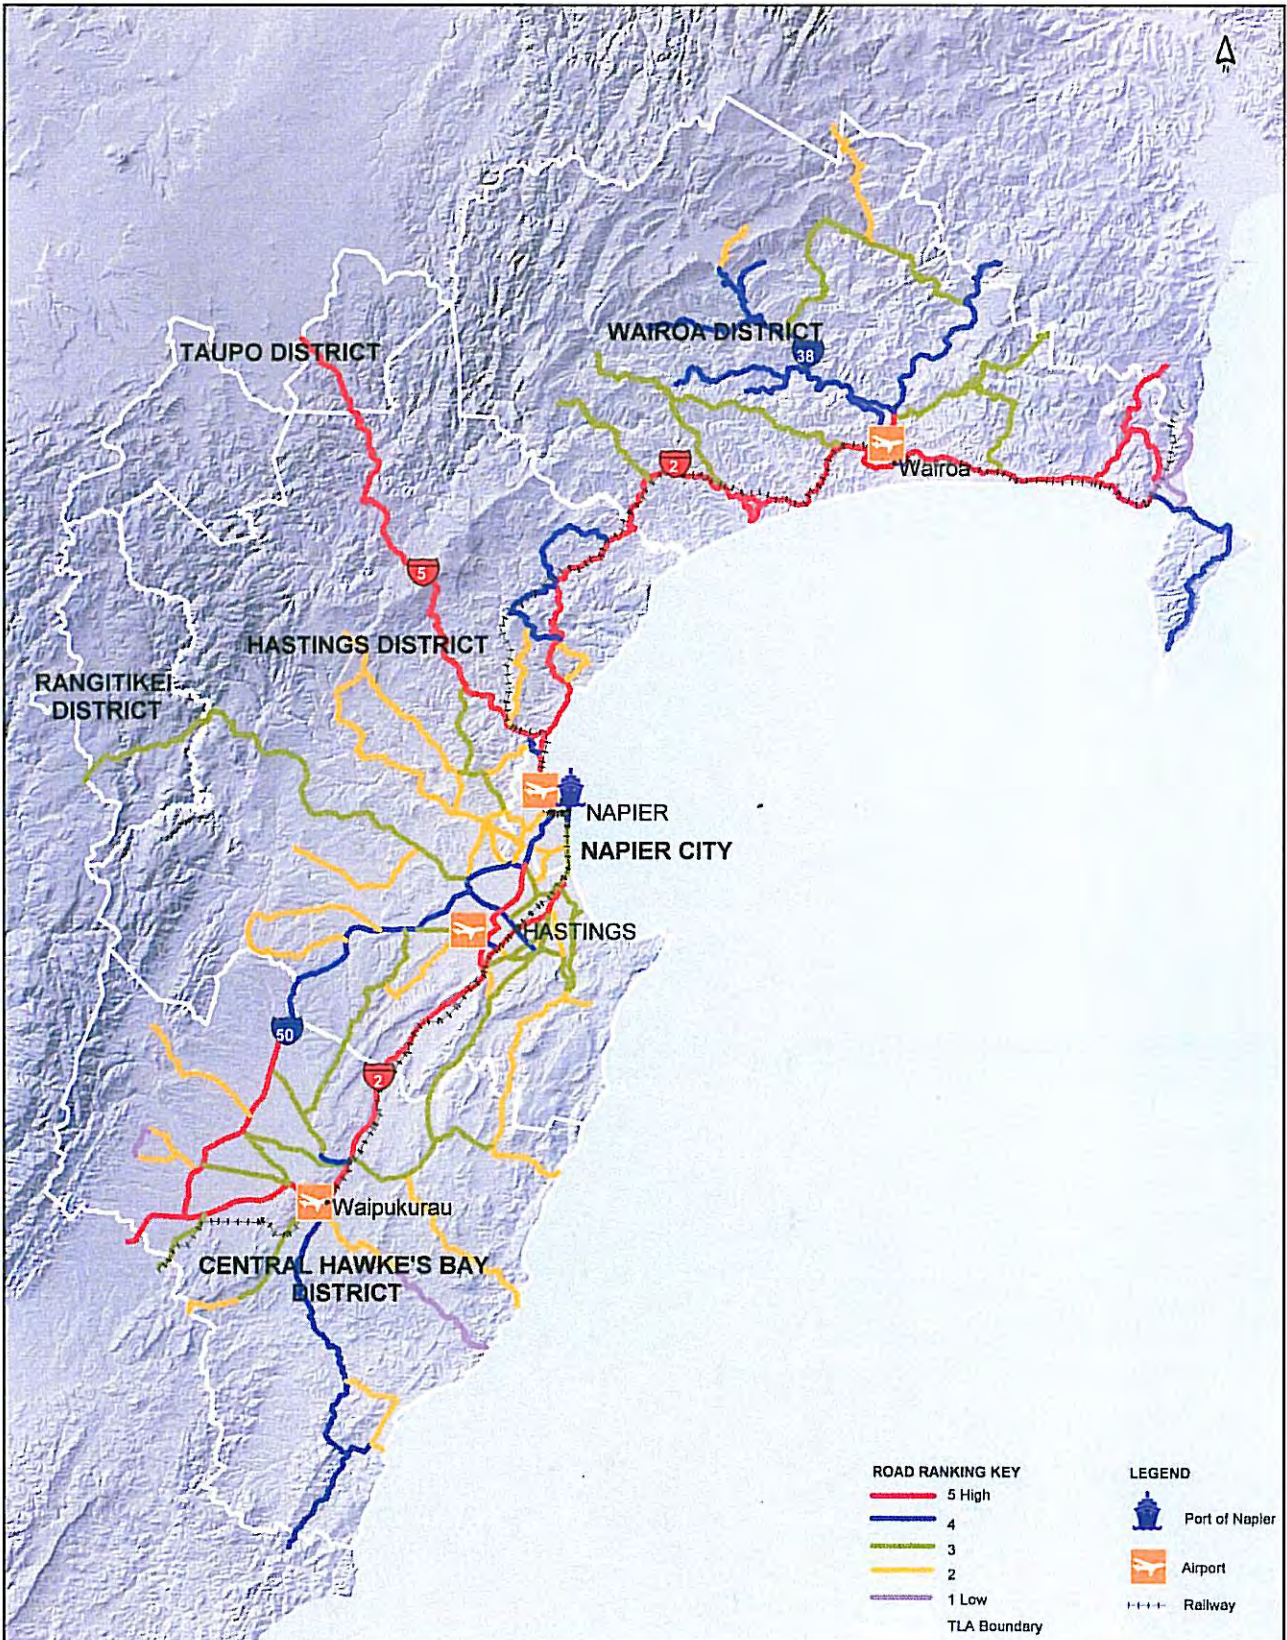
# Map 8

## Transportation Territorial Local Authority Road Ranking

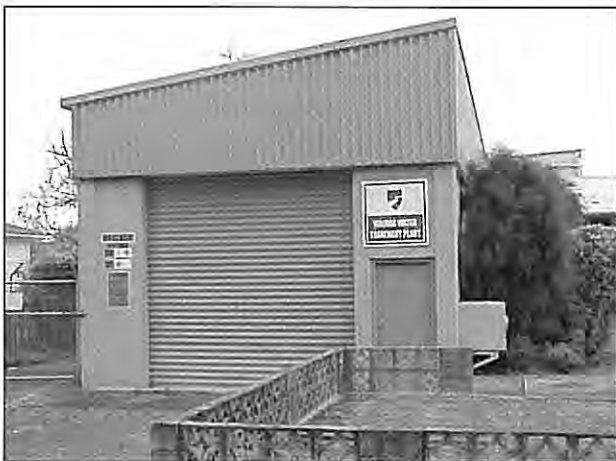
Water treatment plant at Frasertown, Wairoa (Photo courtesy WDC)

The systems include a spring, river and bore sources, pumping stations, treatment plant, reservoirs, reticulation pipework, gravity-fed main, service connections, fire hydrants, valves, water meters, electrical and pumping equipment.

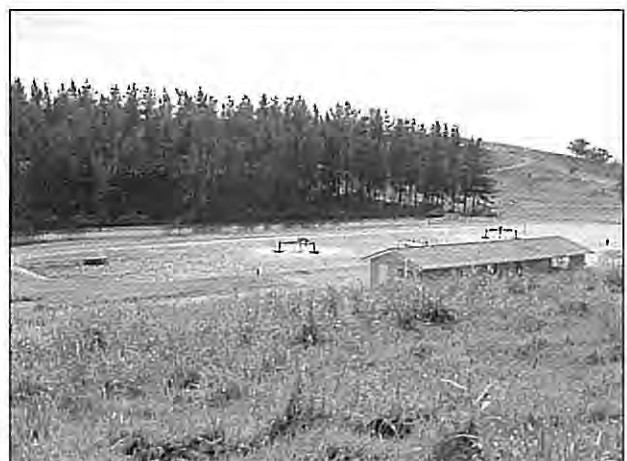
*Wairoa wastewater plant aeration lagoon and control building. (Photo courtesy WDC)*

The system is made up of four areas, each serviced by a pump station. From these stations the sewage is fed into a gravity main which takes it to the final pump station just before the wastewater treatment plant. From here the sewage is pumped to the plant, first entering a pre-aeration lagoon and then an oxidation pond. It is discharged at night into the Wairoa River on an outgoing tide, using a telemetry control system. This ensures it reaches the sea as efficiently as possible.

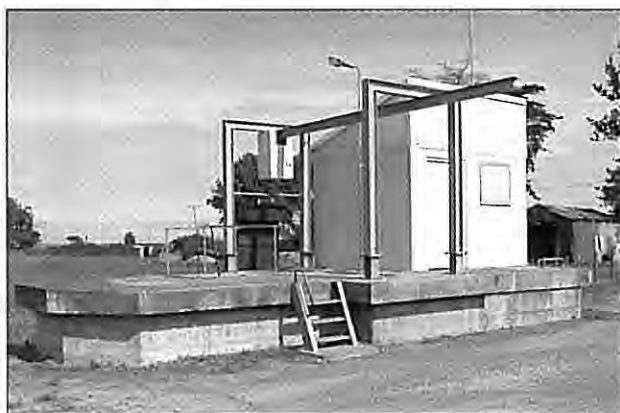
*Fitzroy Street pump station which is the final pump station in the Wairoa system. At this point, the sewage is pumped into the wastewater plant. (Photo courtesy WDC)*

During emergencies the wastewater system can be bypassed at each pump station other than Rutherford Street. The wastewater plant can also be by-passed. Each site has a generator that can be connected to operate the sites in sequence if necessary.

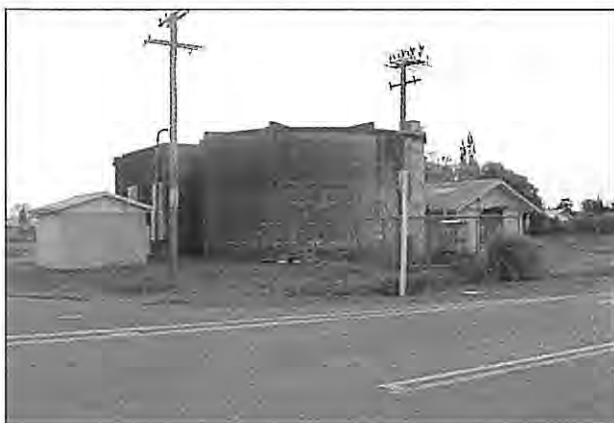
*Boundary Reservoirs and pump station at Wairoa (Photo courtesy WDC)*

Pump stations have the capability to plug in a generator in the event of an emergency and the water treatment plant has a permanent generator that can be quickly actioned.

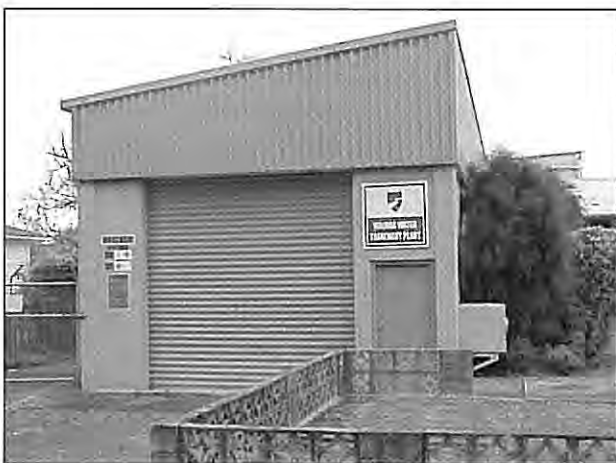
Water treatment plant at Frasertown, Wairoa (Photo courtesy WDC)

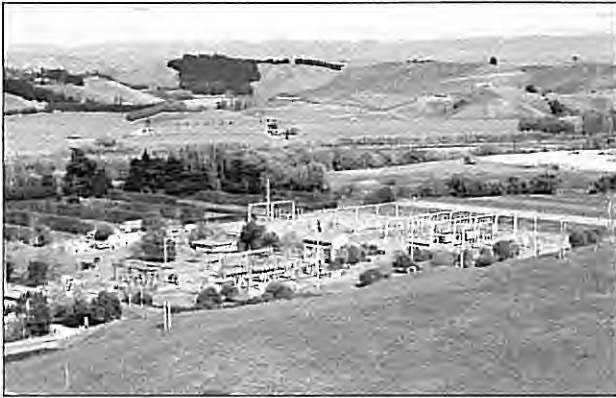
*Redclyffe Substations for Transpower and Hawke's Bay Network showing proximity to the Tutaeakuri River.*

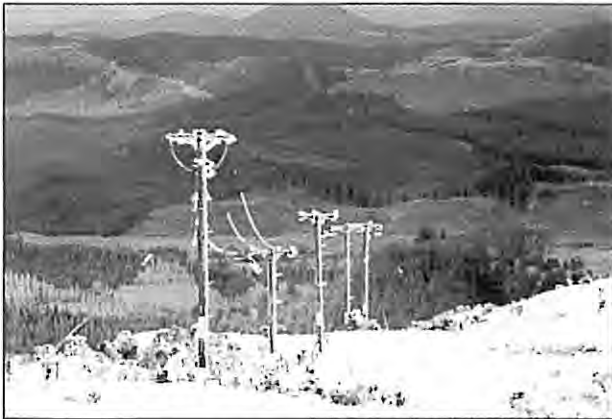
*Power Lines feeding power to TeWaka have had their spans shortened by including extra poles. This was necessary to prevent the combination of ice and wind causing the spans to collapse under the strain.  
(Photo courtesy Ian Greaves Telecom)*

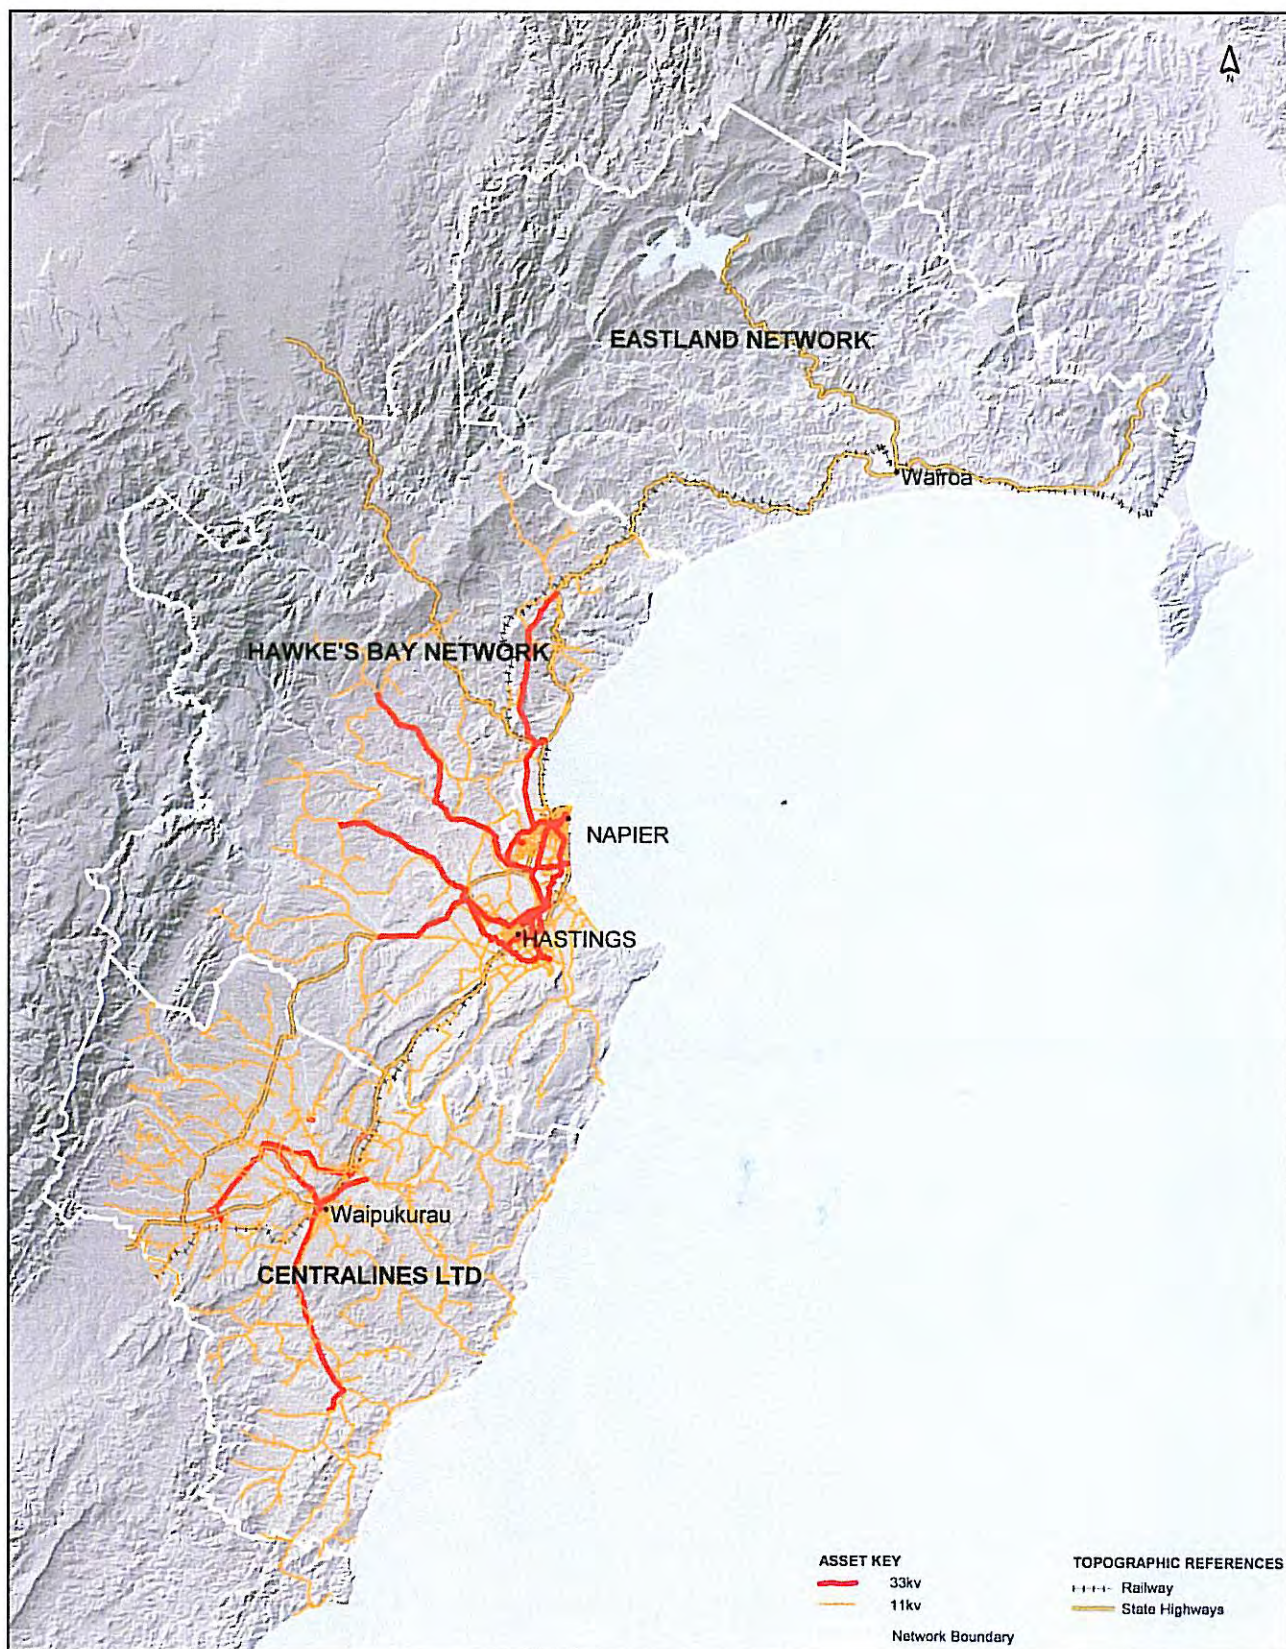
# Map 18

## Energy Transpower Network

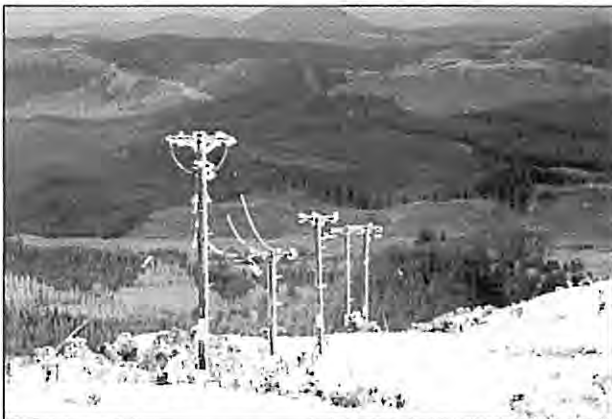
*Power Lines feeding power to TeWaka have had their spans shortened by including extra poles. This was necessary to prevent the combination of ice and wind causing the spans to collapse under the strain.  
(Photo courtesy Ian Greaves Telecom)*

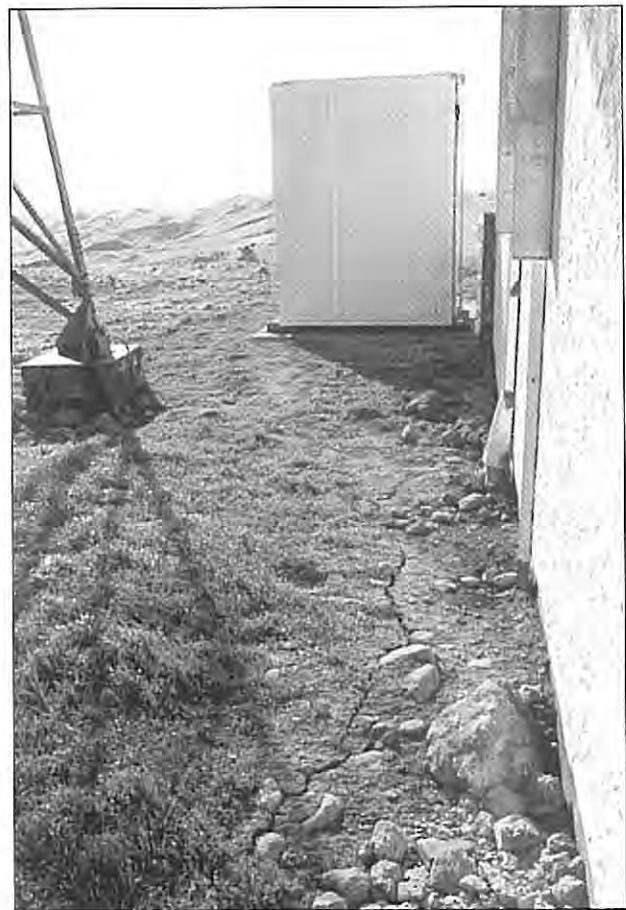
*Photo taken on the North side of Takapau Microwave Radio Station after an earthquake event which occurred during the mid 1980's. There is evidence of backfill settlement around the foundations of the building and tower footings. (Photo courtesy Ian Greaves Telecom)*

Most radio sites have been purpose built for the equipment they house and have had extensive seismic bracing work carried out in the last 10 – 15 years. Wind loading on the towers tends to be conservative. (usually greater than 200kph). Ice formation is the only natural event that has caused damage at these sites in the past. Some sites are more prone to this hazard than others, probably because of a combination of altitude and latitude. A typical scenario is for lumps of ice to break off the upper regions of the structure and damage other parts on its way down. As a mitigation measure, ice shields have been attached above vulnerable antenna at affected sites. The other problem results from wind, sleet and snow combining to form "flag ice" where large horizontal, flags of ice form on parts of the antennas, creating torsion (twisting) forces which can either bend or break the section to which they are attached. To prevent this problem, Telecom installs antenna types that are less susceptible to damage from flag ice.

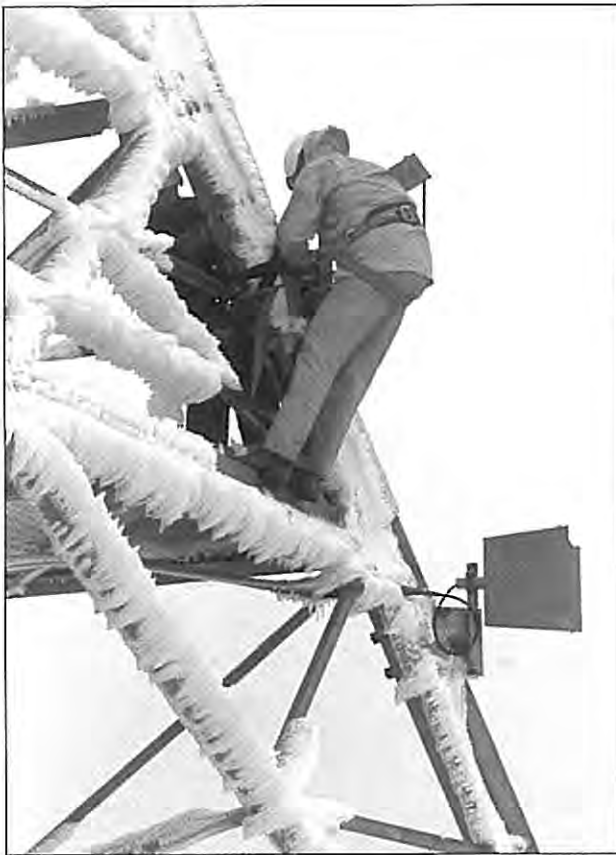
*A rigger is clearing ice away from a corner reflector antenna on the Te Waka Microwave tower. The lower antenna has already been cleared of ice and should now be performing normally. The formation of "Flag Ice" on this structure is not uncommon.  
(Photo courtesy Ian Greaves Telecom)*

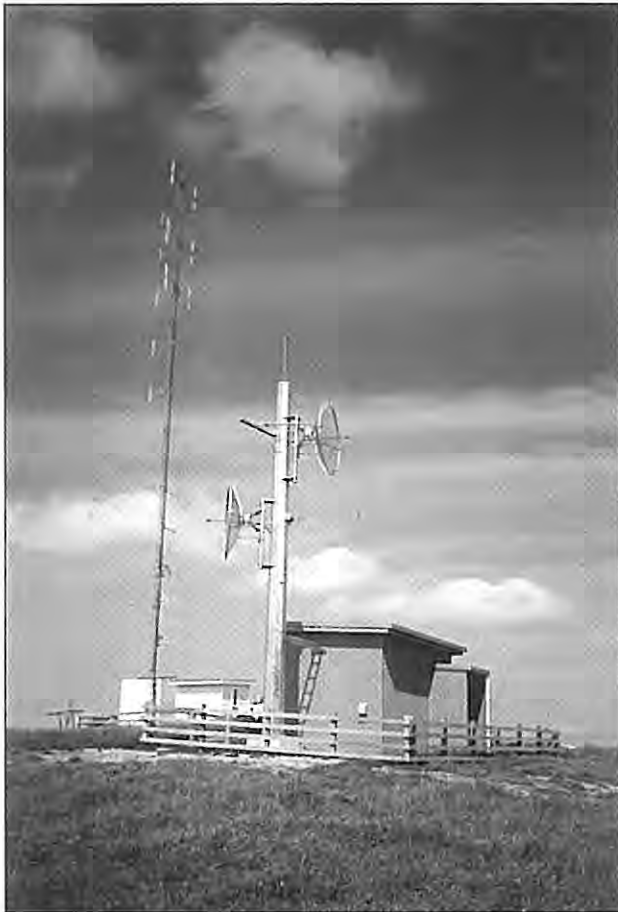
*Rangitoto radio site, Transpower Hut and Discs Tower Hill  
(Photo courtesy Garth Cassidy)*

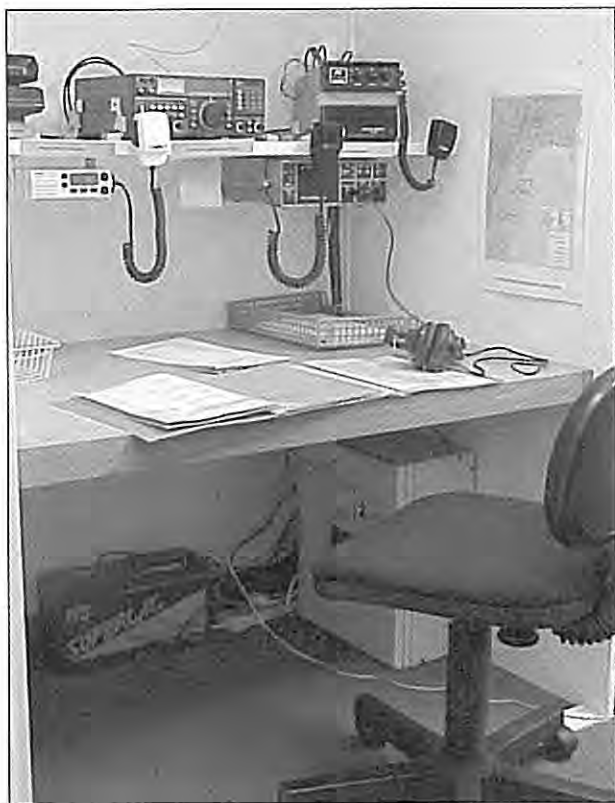
*Radio equipment at the Regional Emergency Operations Centre-Hawke's Bay Regional Council.*

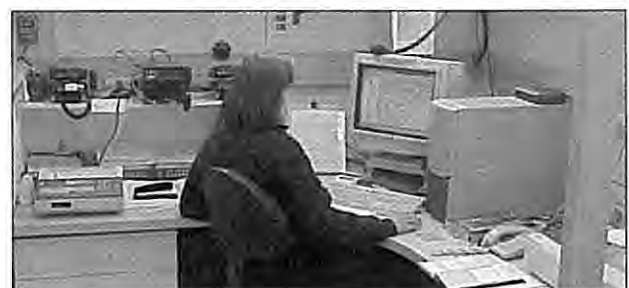
*Telemetry room at the Hawke's Bay Regional Council October 2001.*

Some of the networks and equipment identified above are capable of transferring data from remote sites to centralised monitoring control centres.

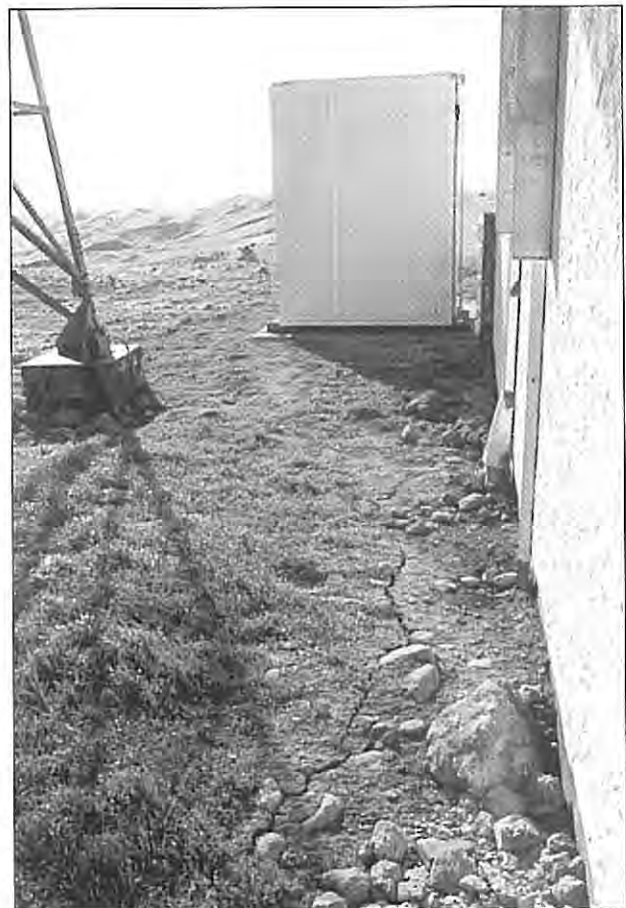
*Photo taken on the North side of Takapau Microwave Radio Station after an earthquake event which occurred during the mid 1980's. There is evidence of backfill settlement around the foundations of the building and tower footings. (Photo courtesy Ian Greaves Telecom)*

Most radio sites have been purpose built for the equipment they house and have had extensive seismic bracing work carried out in the last 10 – 15 years. Wind loading on the towers tends to be conservative. (usually greater than 200kph). Ice formation is the only natural event that has caused damage at these sites in the past. Some sites are more prone to this hazard than others, probably because of a combination of altitude and latitude. A typical scenario is for lumps of ice to break off the upper regions of the structure and damage other parts on its way down. As a mitigation measure, ice shields have been attached above vulnerable antenna at affected sites. The other problem results from wind, sleet and snow combining to form "flag ice" where large horizontal, flags of ice form on parts of the antennas, creating torsion (twisting) forces which can either bend or break the section to which they are attached. To prevent this problem, Telecom installs antenna types that are less susceptible to damage from flag ice.

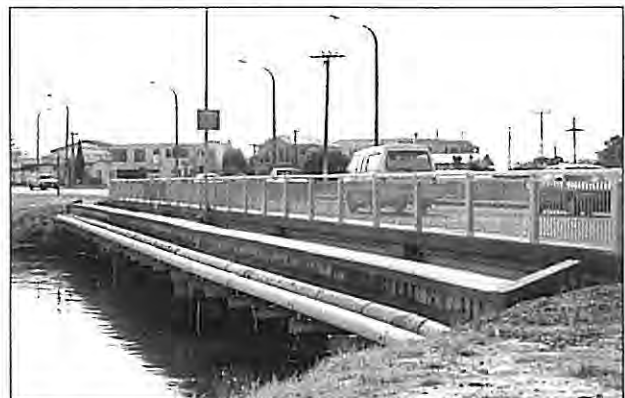
*Westshore Bridge on State Highway 2 is a critical lifeline for many utilities. The expressway northern extension when constructed, will mitigate the roading transportation dependence on this structure.*
