**Mapping of Active Faults and Fault Avoidance
Zones for Wairoa District: 2016 Update**

**GNS Science Consultancy Report 2016/133
January 2017**

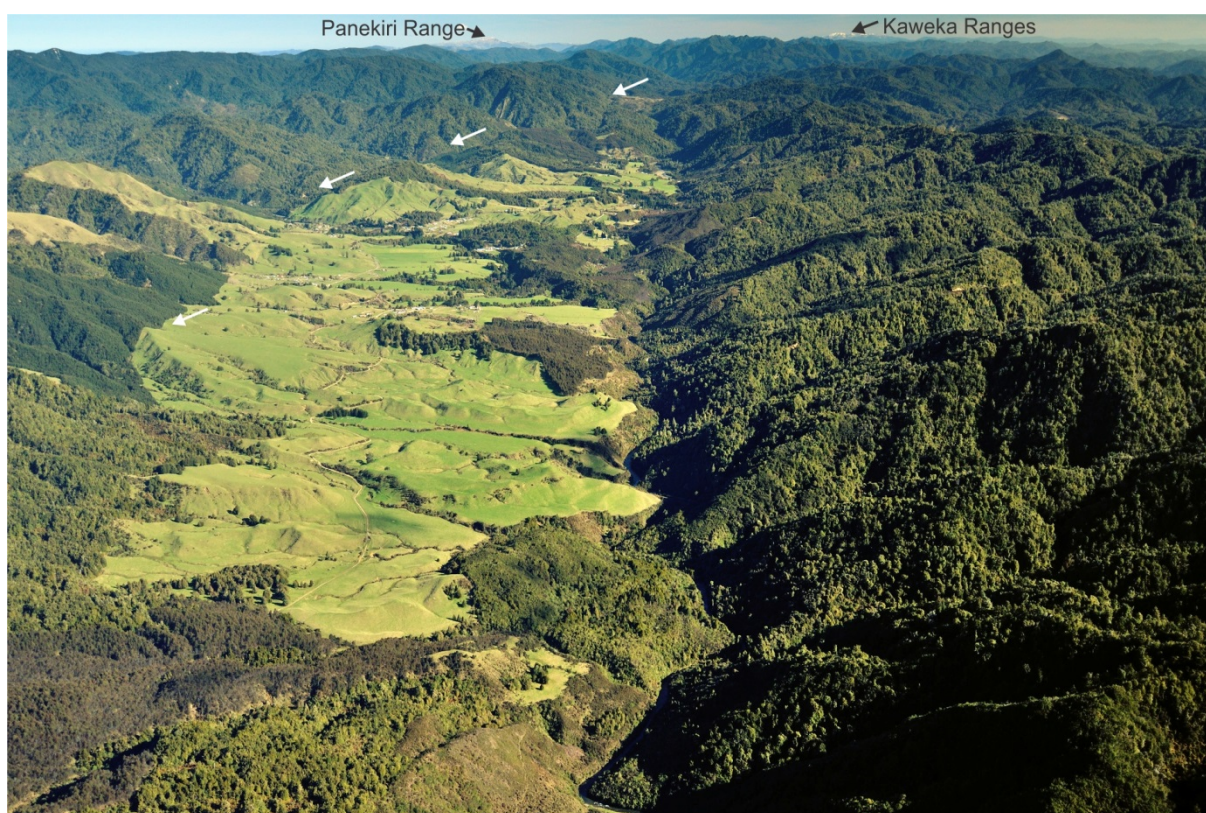
Figure 2.4 Oblique aerial photograph of the Whakatane Fault (white arrows point to fault trace) running through the Ruatahuna basin. The photo perspective is looking southward toward the Wairoa District. Photo credit: Dougal Townsend, GNS Science.

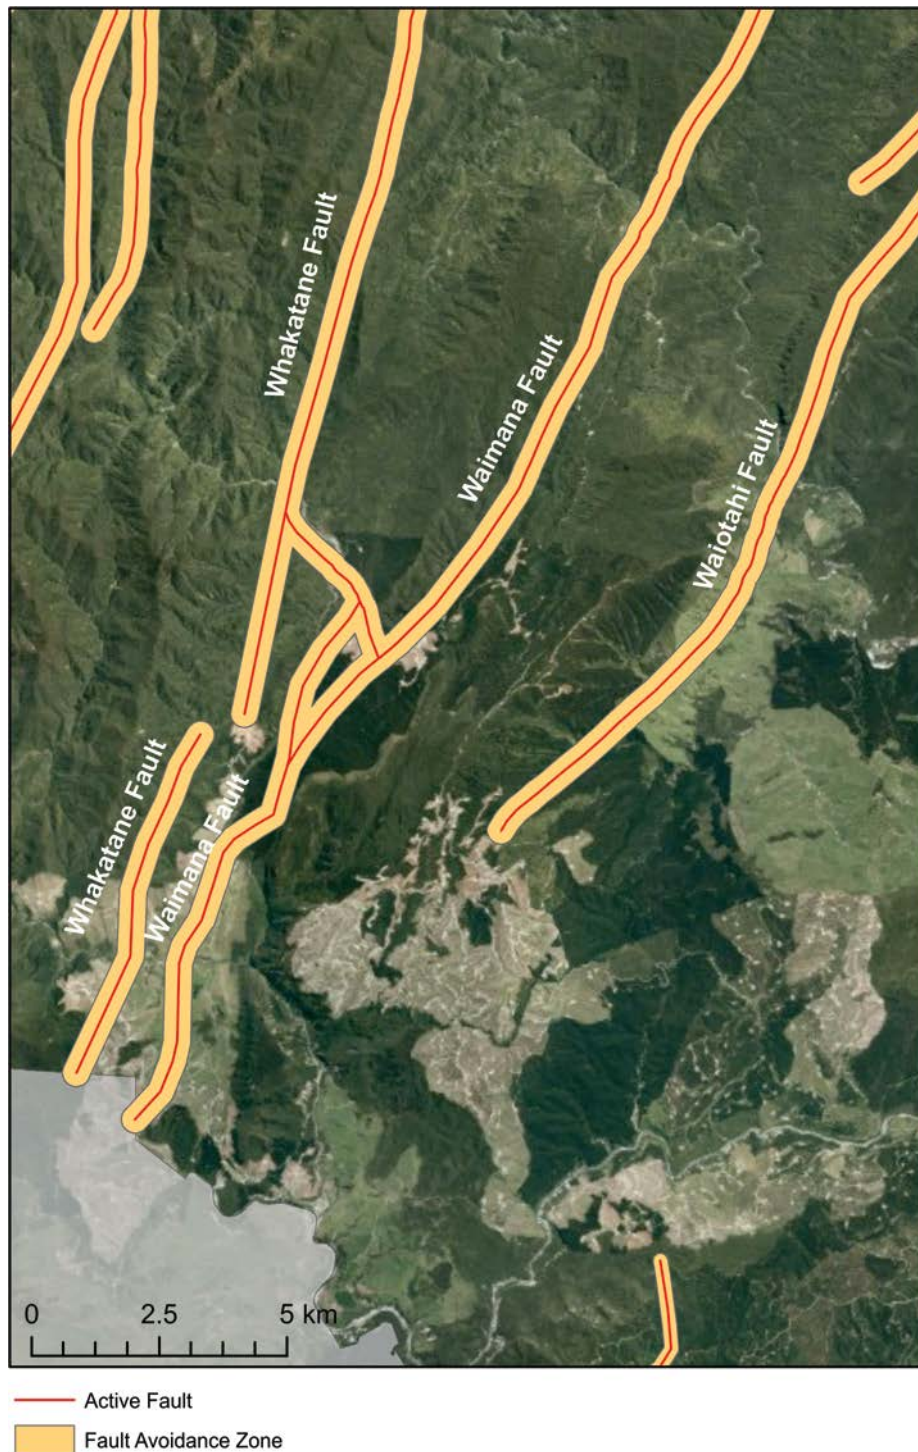
Figure 3.1 Detail of the Whakatane Fault and Waimana Fault in the southern part of the Wairoa District. Revised line work in this report and Fault avoidance Zones

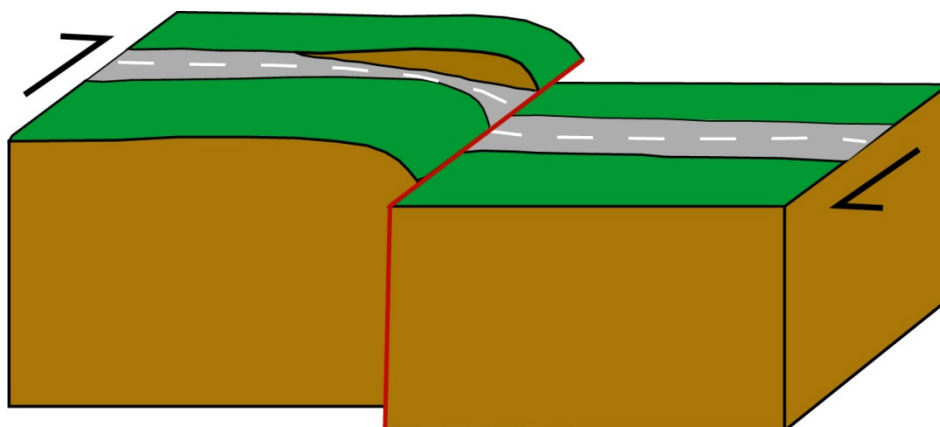
Figure A1.2 Block model of a strike-slip fault (Figure A (red line)). The fault is a right-lateral fault as shown by the black arrows and by the sense of movement across the two blocks and a right separation across the road.

Faults can be categorised as: strike-slip faults, where the dominant style (sense) of motion is horizontal (movement in the strike direction of the fault), and dip-slip faults, where the dominant sense of motion is vertical (defined by movement in the dip direction of the fault). Strike-slip faults are defined as either right-lateral (dextral), where the motion on the opposite side of the fault is to the right (Figure A1.2), or, left-lateral (sinistral) where the opposite side of the fault moves to the left.
